EXECUTIVE SUMMARY

Needs assessment & concept development update, August 2018.

Building Survey for Keller Senior Activities Center, 660 Johnson Road, Keller, Texas
July 2017

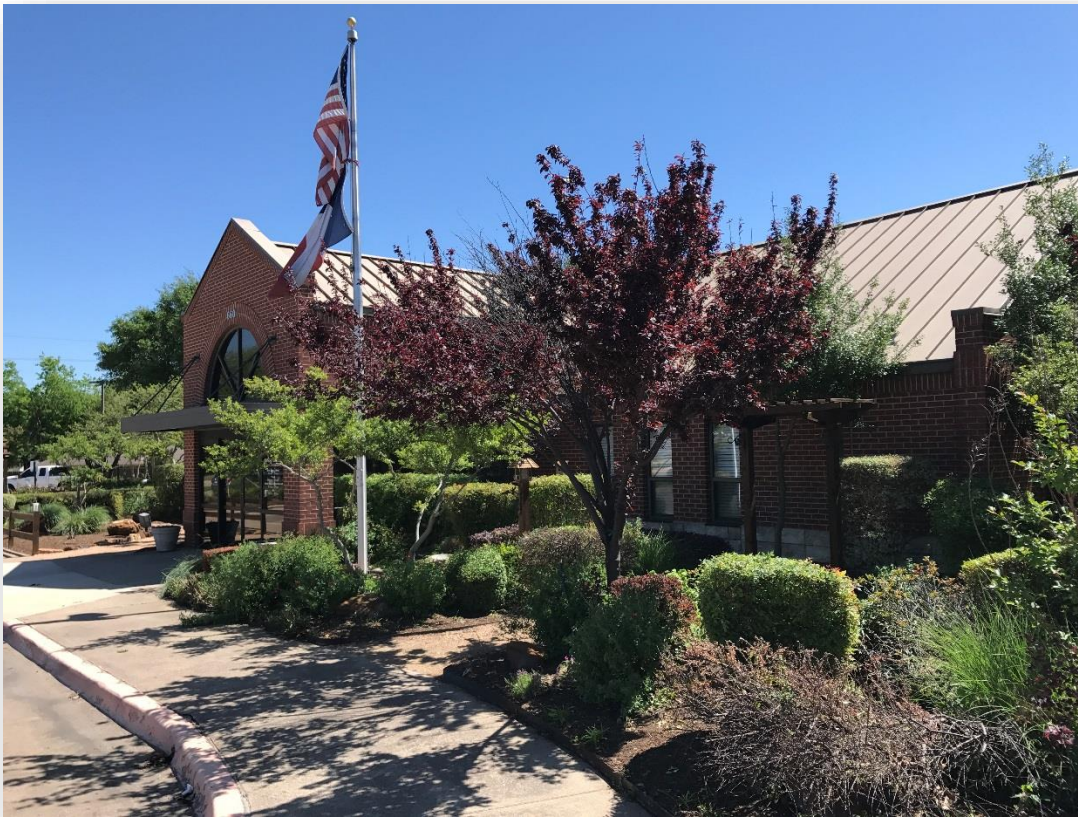
Front approach

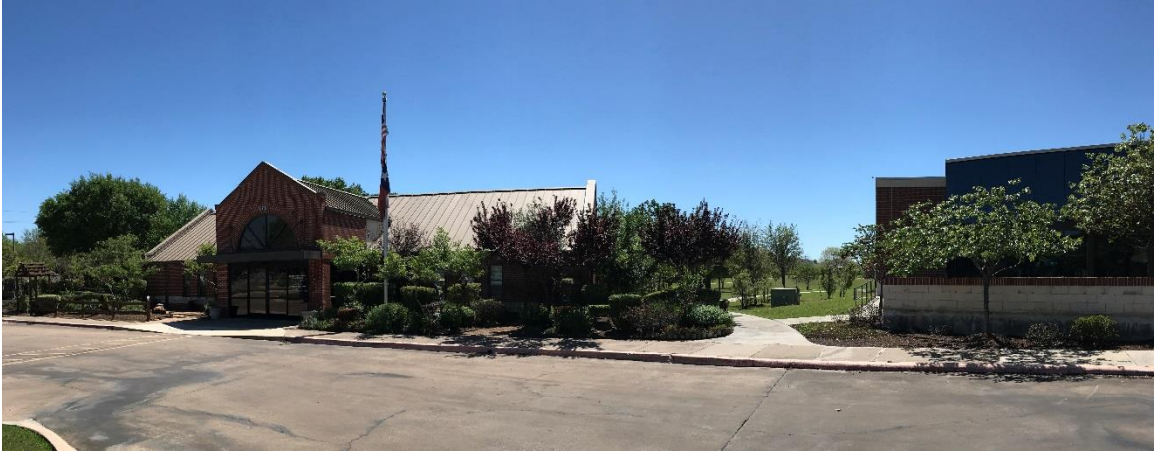
NW View from parking, and of adjacent library

Parking is shared with the adjacent library. An added lot east of the center is less obvious for a newcomer to find and is not convenient to the front door. Overall, parking capacity appears adequate for most day-to-day usage. Capacity can be stressed at peak times, especially if events at both facilities overlap. A higher ratio of accessible parking is advantageous at senior facilities, but this comes at expense of capacity. It has been observed that overflow from the nearby high school impacts this parking lot during the school year, though it is reported that this should be alleviated by the district separate of this study project.

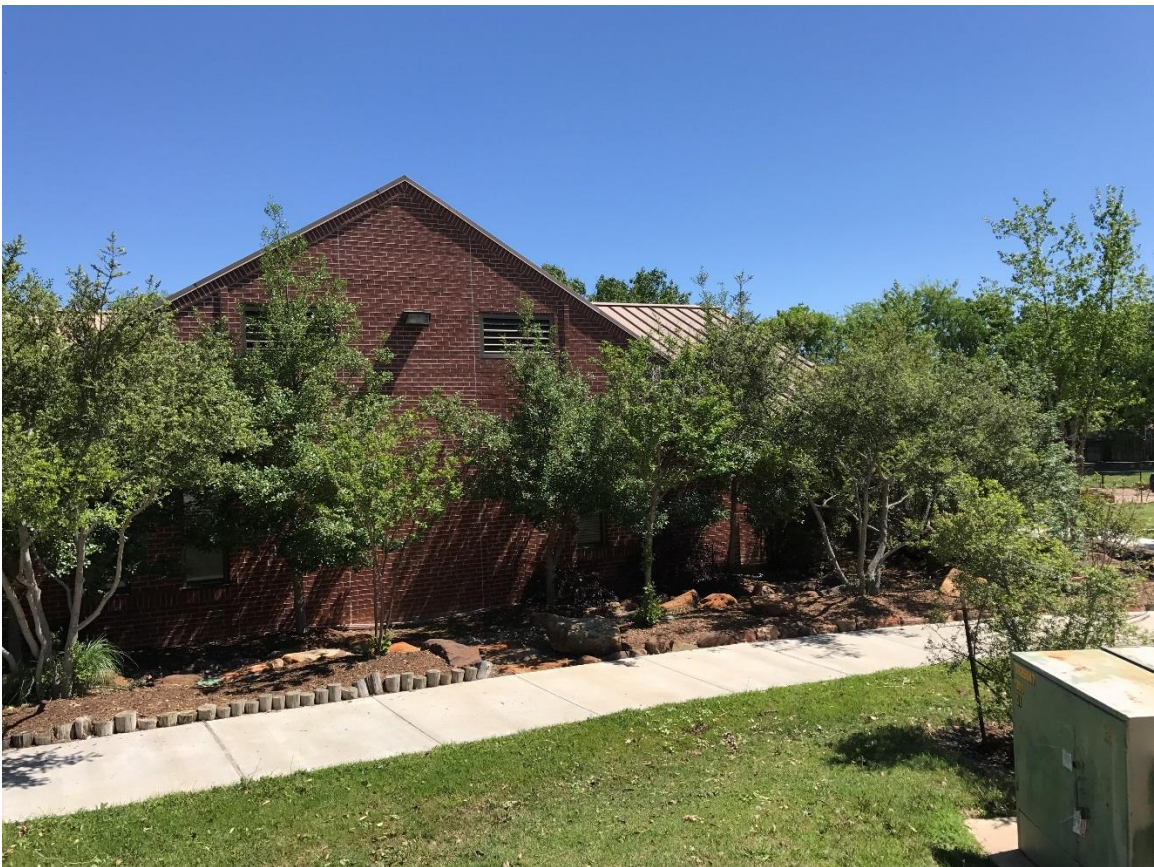
West elevation

The entire building is clad with brick. Entrances are storefront assemblies and windows are double-hung. Most of it appears to be insulated and tinted. All assemblies appear to be original to their dates of construction. No noticeable leaks were observed.

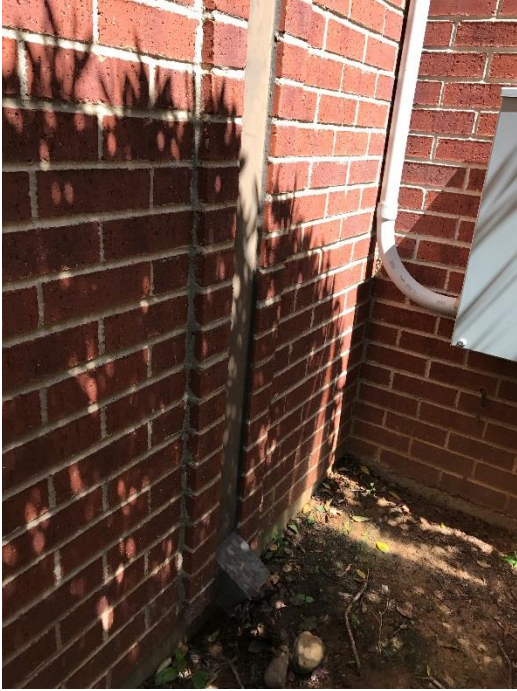
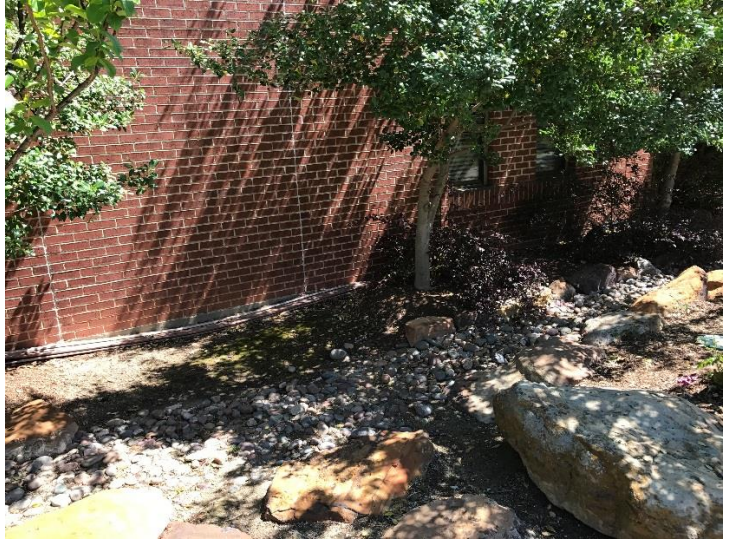
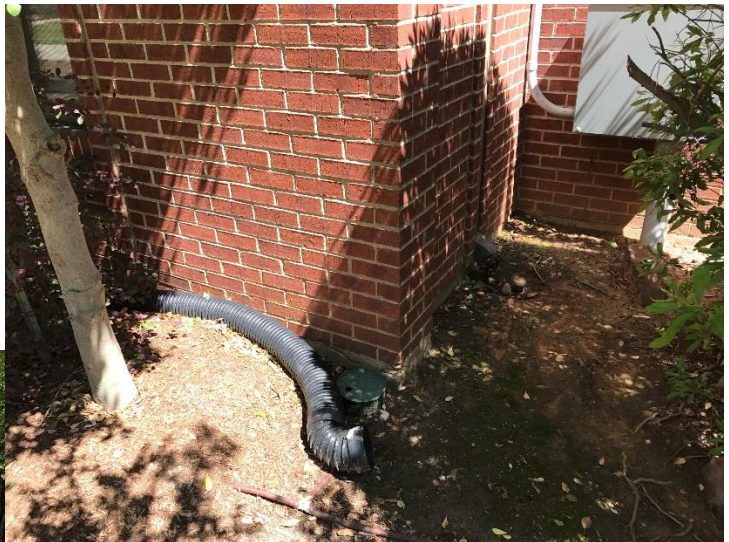
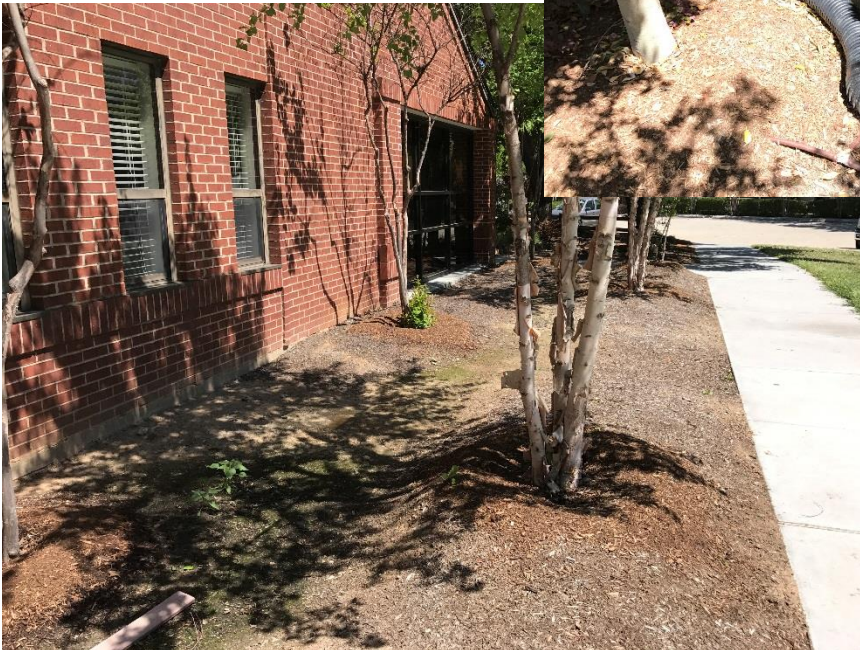
An in-depth site survey is not part of this assessment, but drainage is an obvious problem within the park and near this structure. There is a mixture of open and closed drainage systems on the site, with the open system appearing partially silted. The park appears to have the lowest elevation in the surrounding area, generally draining openly from northwest to southeast, where a culvert then conveys water underground to the northeast, passing south and east of the senior center. This storm line also poses a restriction to expansion of the current center. We recommend that an in-depth drainage analysis of the park be undertaken to inform future development of the park.

Images of drainage issues near structure

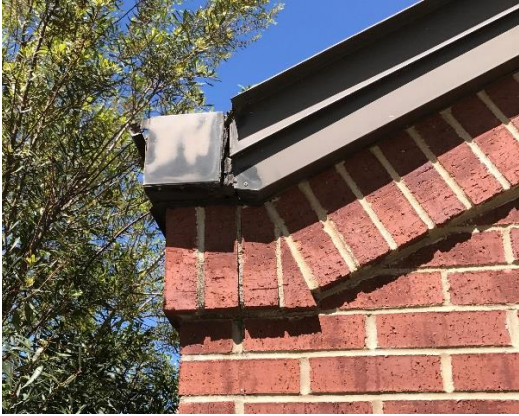
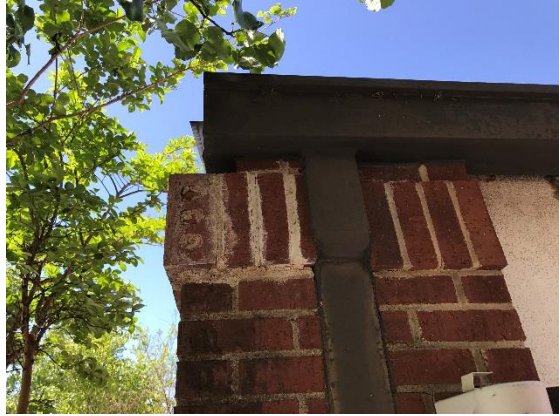
A number of trees are planted too close to the building and could cause foundation issues. Vegetation around the building has encouraged mildew growth in a number of places, and inhibited routine maintenance of gutters, downspouts and sealants. Isolated areas of water damage are evident and in need of attention.

Images of early water damage

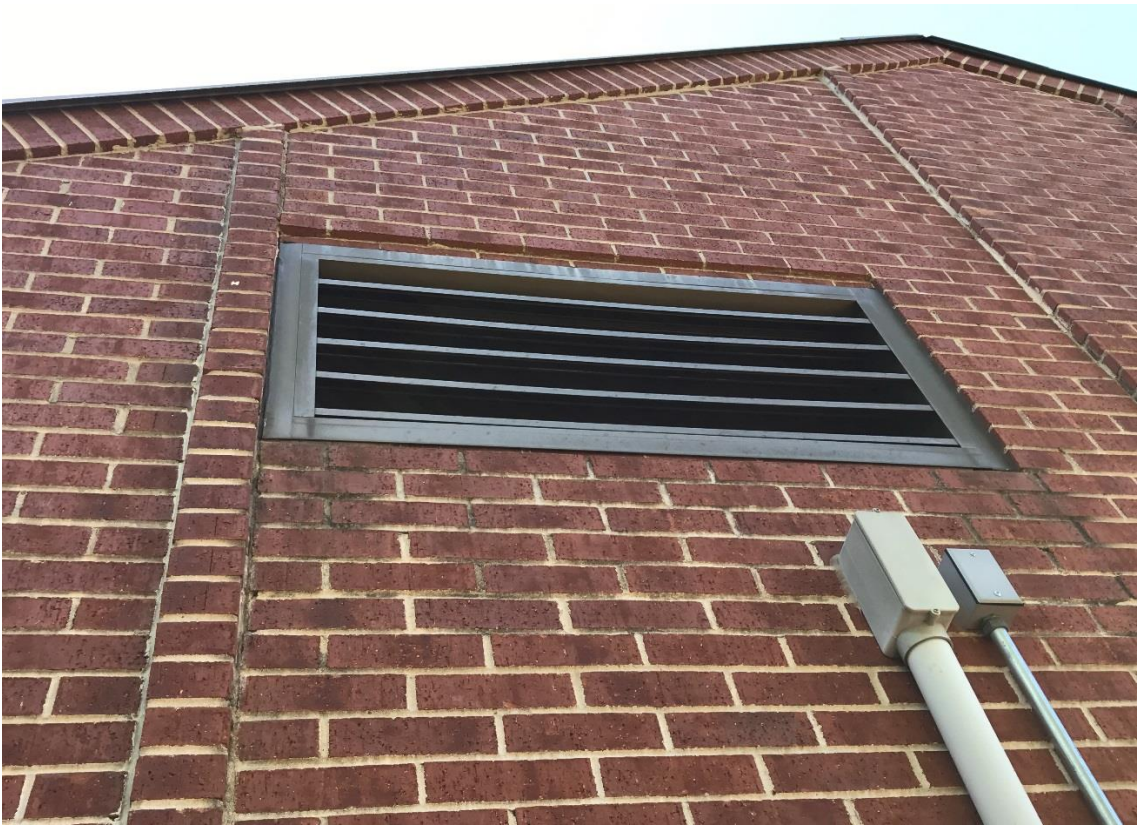
Mildew growth and sealant failures.

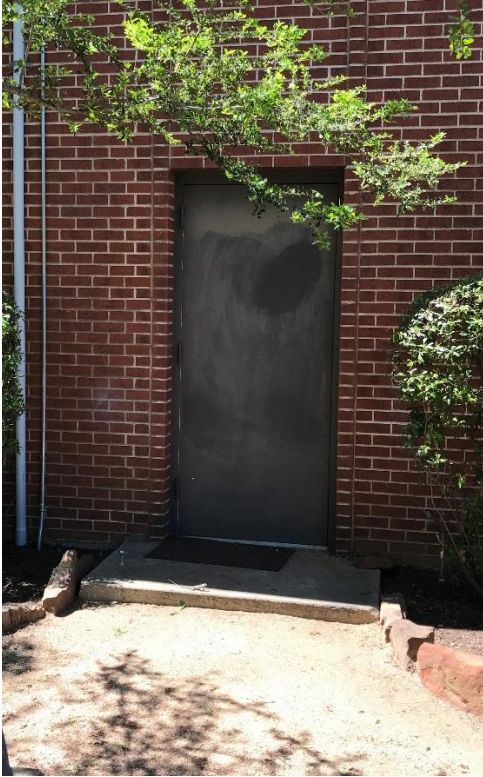
An exit door on the east side of the building does not provide an accessible route to safety.

Non-ADA compliant exit

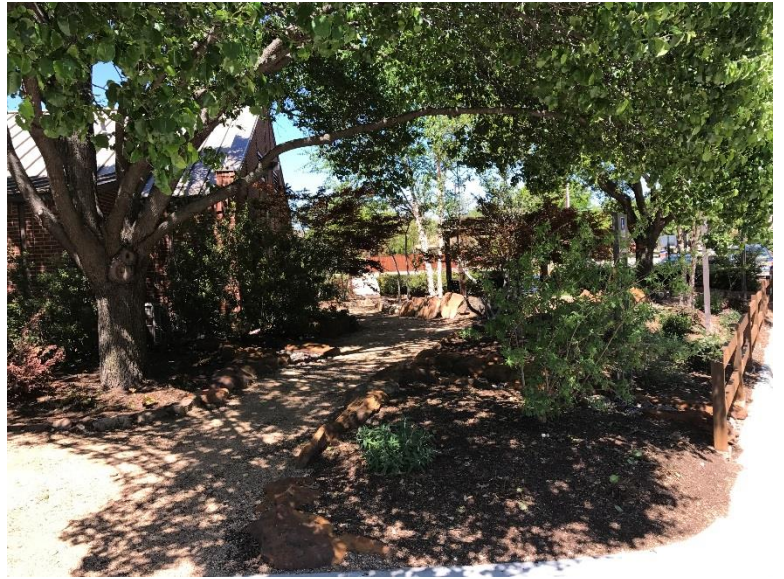
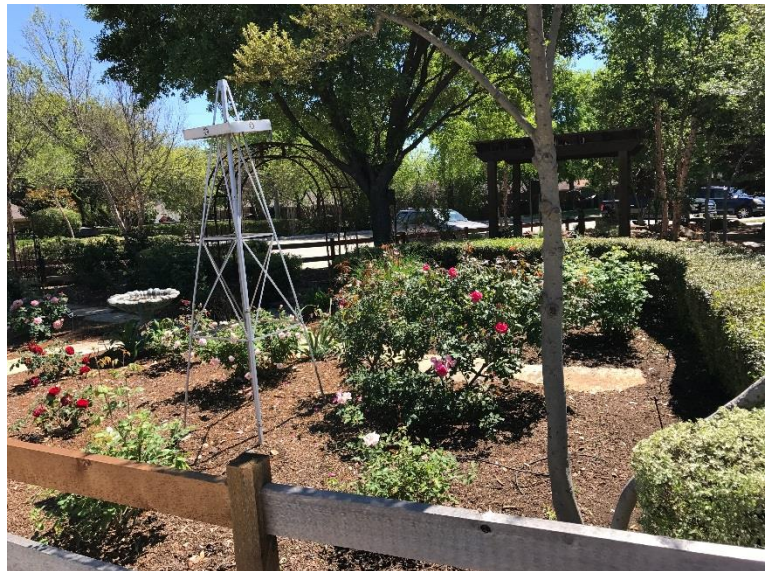
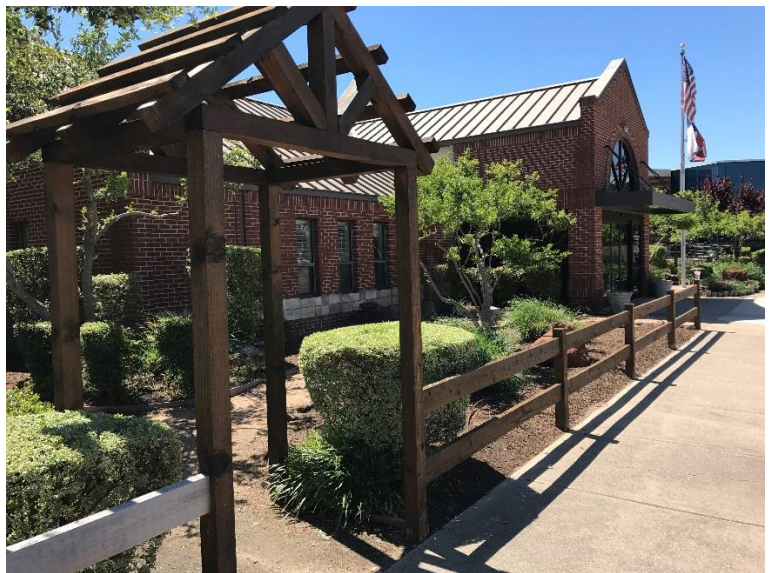
Garden Areas →

The site immediately near the center benefits from mature trees and well-loved landscaping at least partially maintained through volunteer groups. Landscaping near the building is overgrown in places, which can inhibit maintenance and conceal drainage problems and vermin. A number of trees are planted too close to the building and could cause foundation problems in the future. There is poor drainage near the building where bedding areas create ponding water near the foundation. No significant cracking was observed at time of visit.

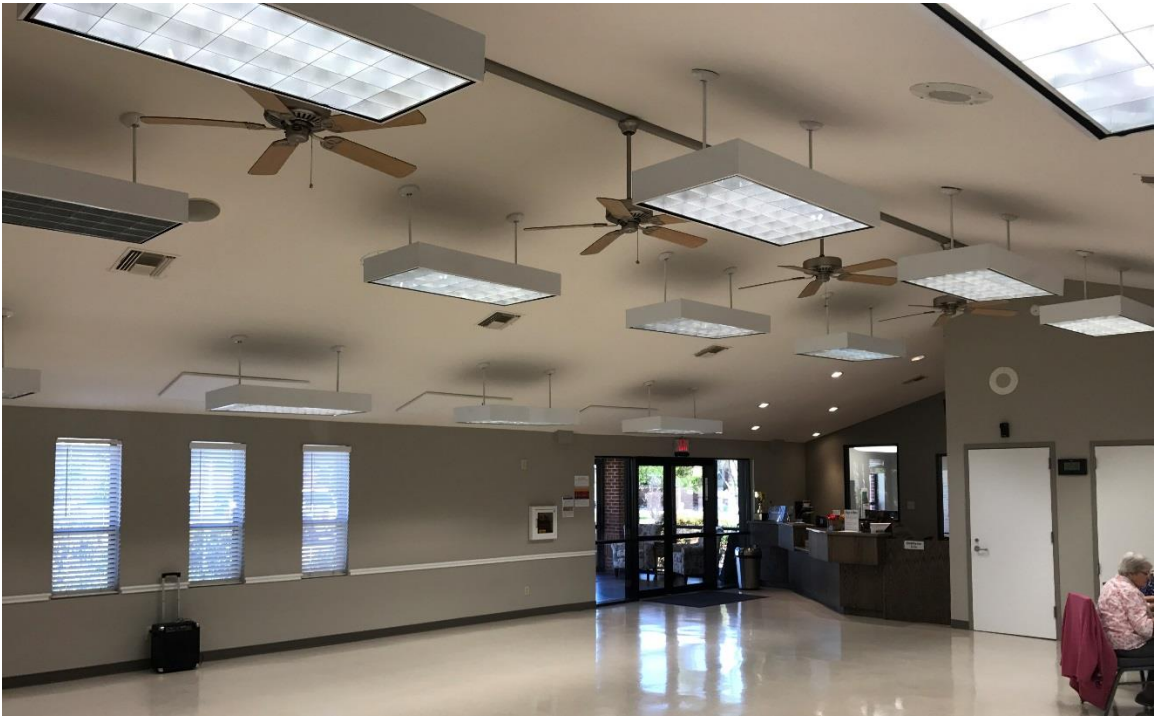
Activity Room

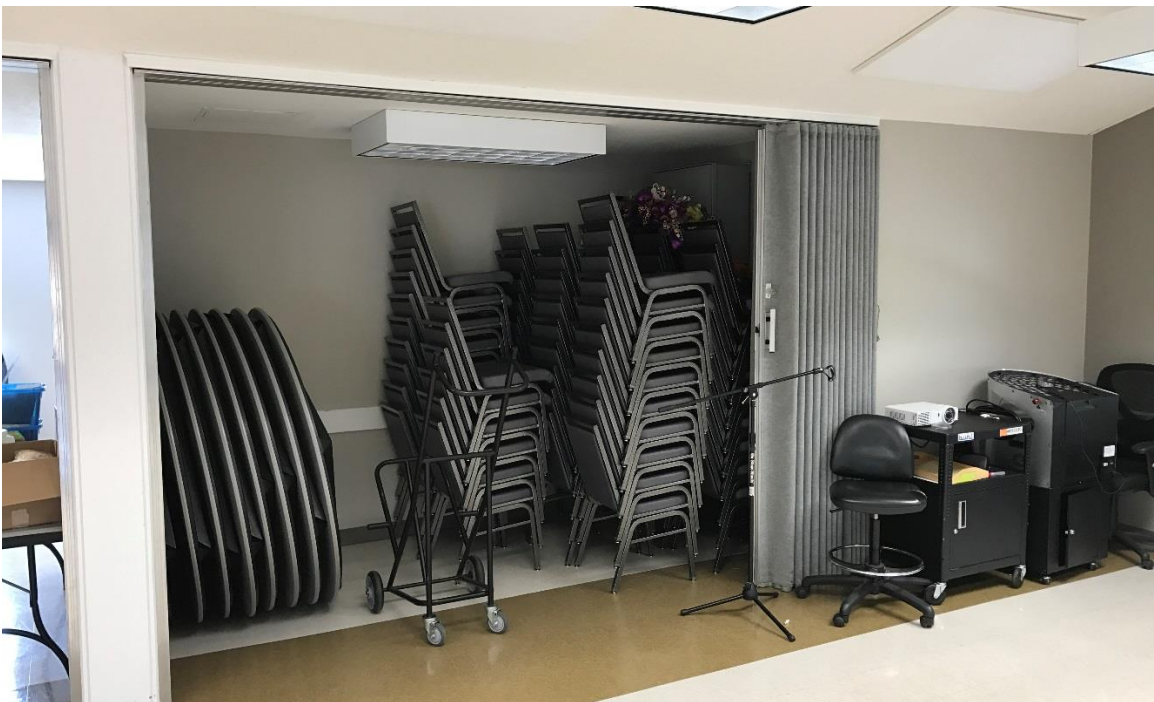
At 4,236 SF, the building is currently undersized for the intended use. Beyond the main activity room, program spaces are small and lack capacity for hosting popular programs. Storage rooms are not sized to support current functions, causing spill-over into other spaces.

Activity Storage

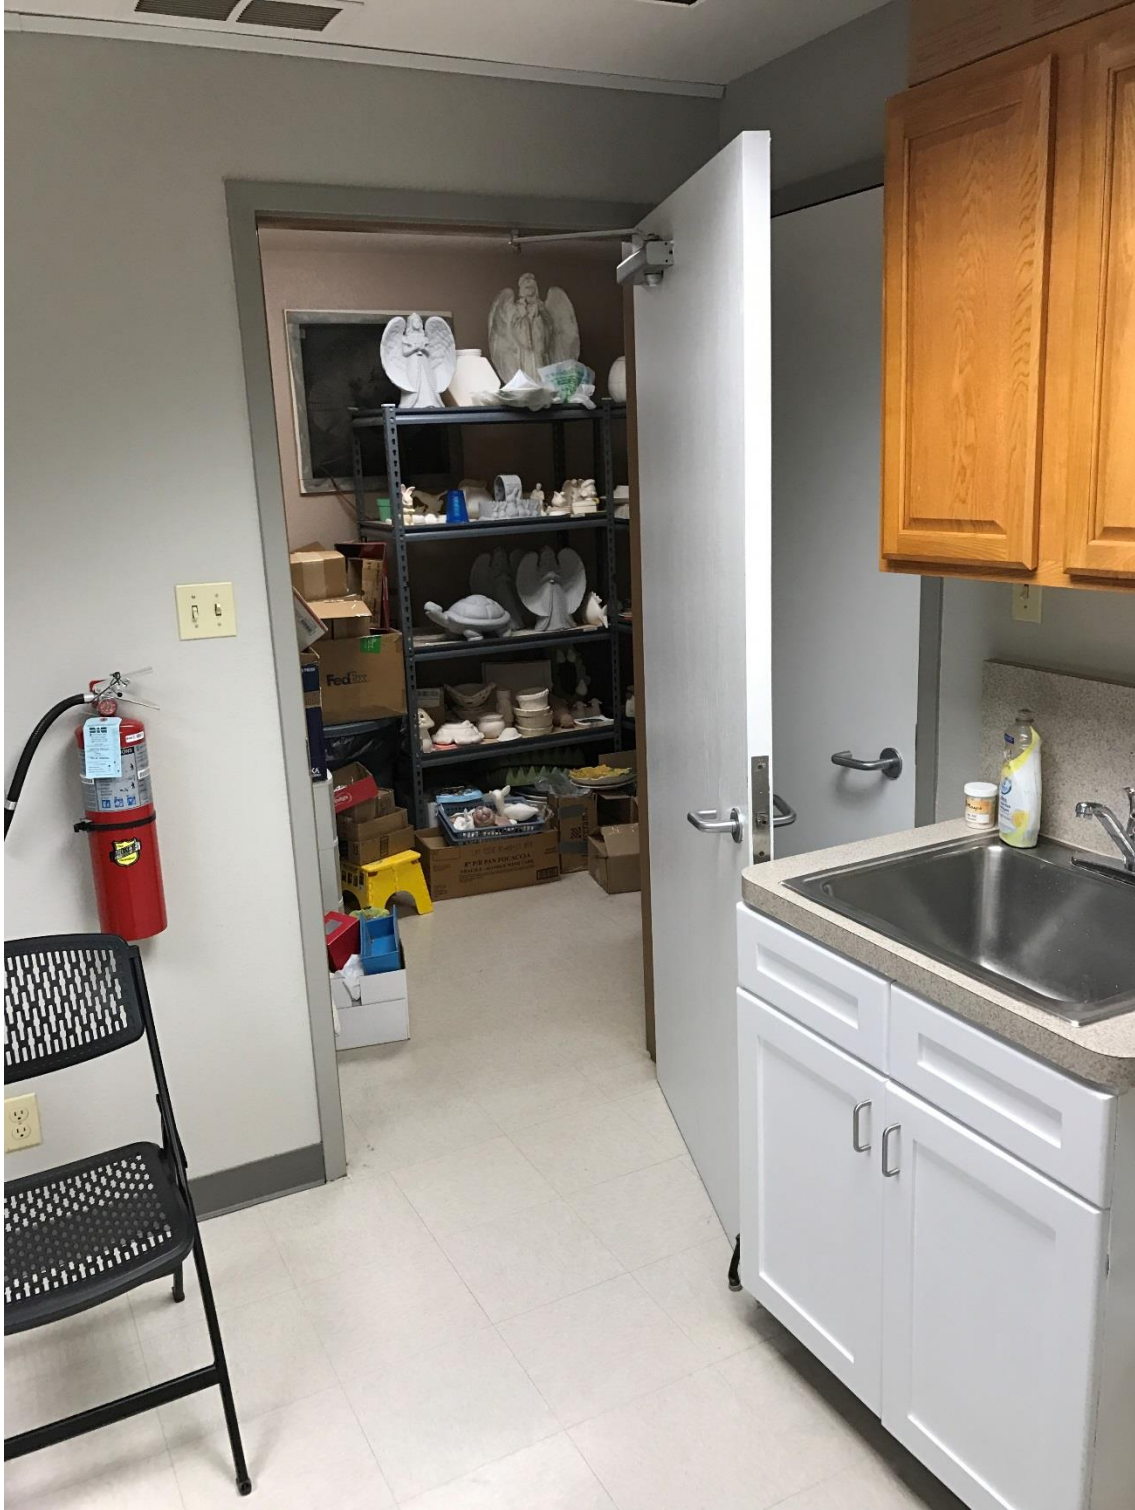
Ceramics – Non-ADA compliant doors & sink

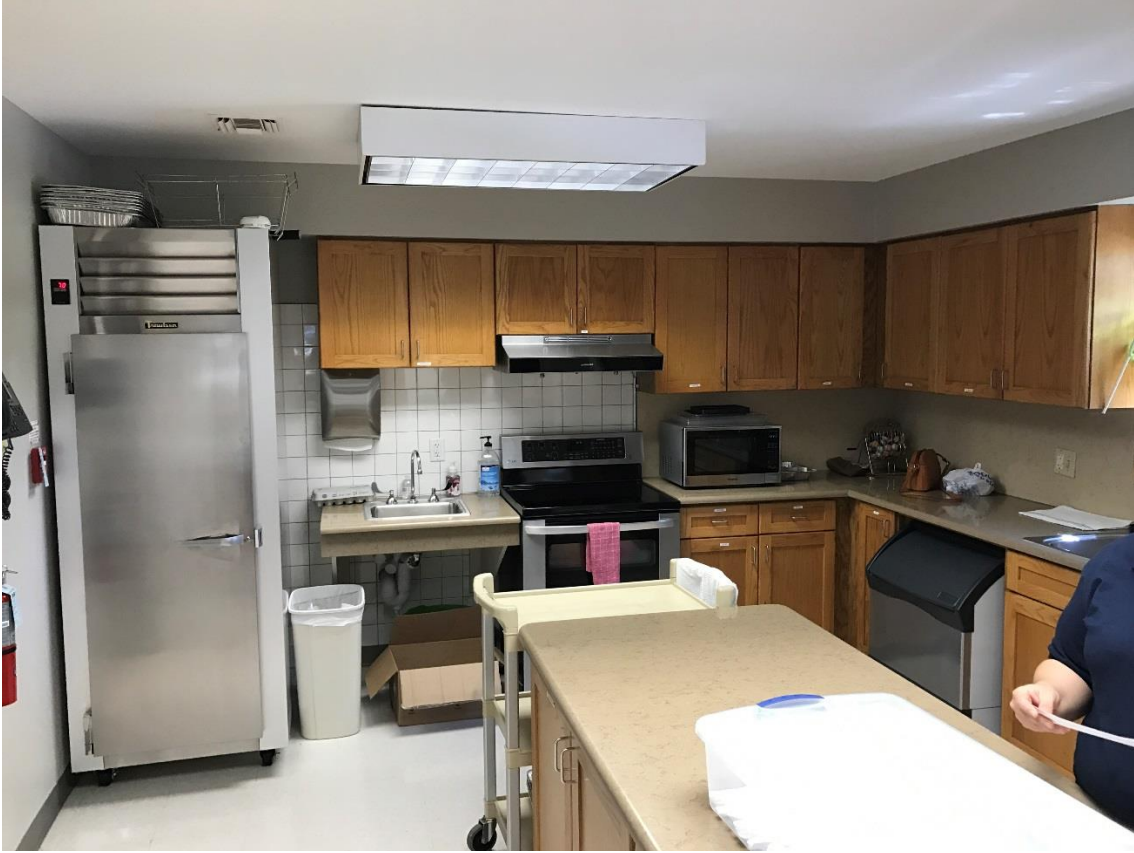
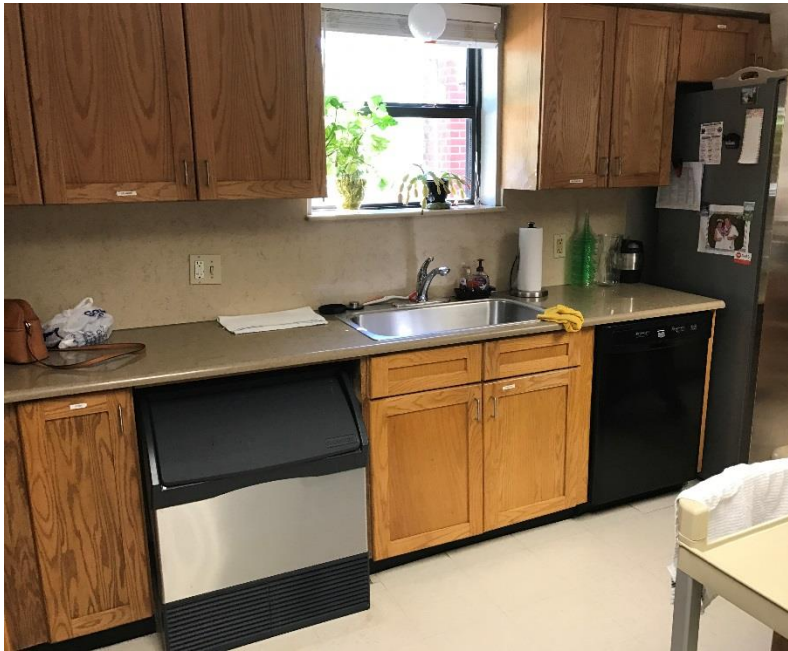
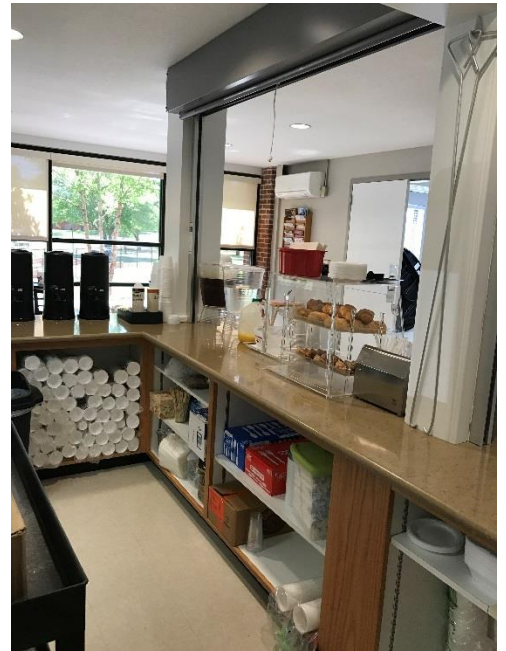
Kitchen

Ceilings and wall partitions are typically painted gypsum board. Ceramic tile is used on walls of the restrooms. Doors are typically wooden and painted white. Floors are typically vinyl composition tile. The new control desk has durable solid surface counters and laminate fronts. The kitchen also has solid surface counters. The rest of the casework is laminated counters and hardwood fronts, most of which has recently been painted white except for the newer kitchen. Painted cabinet fronts will show age and wear very quickly.

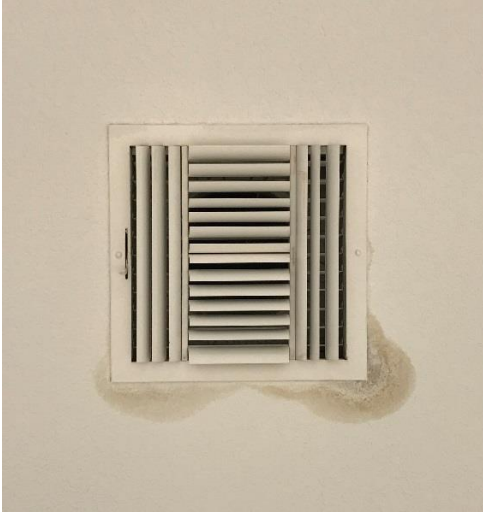
Condensation damage

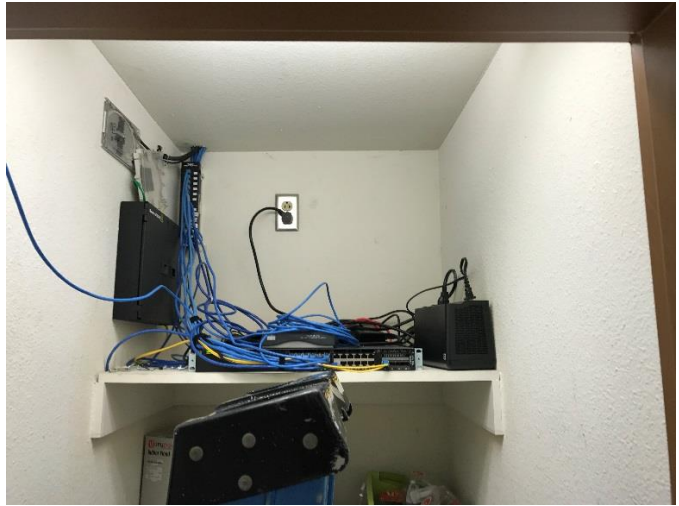
The electrical equipment is located in the ceramics room and is accessible to the public. Data equipment is located in the closet in this room. Ideally such equipment would be isolated in their own closet(s). Use of technology has of course matured immeasurably since the original construction, and its integration into the building over time has been ad hoc and would benefit greatly from an overhaul. Outdated built-in audio systems appear to be in place, though their functionality was not tested at the time of visit. Portable A/V systems are also being used. There is no cable or satellite TV system in the building. Public wifi is available to patrons.

Data closet

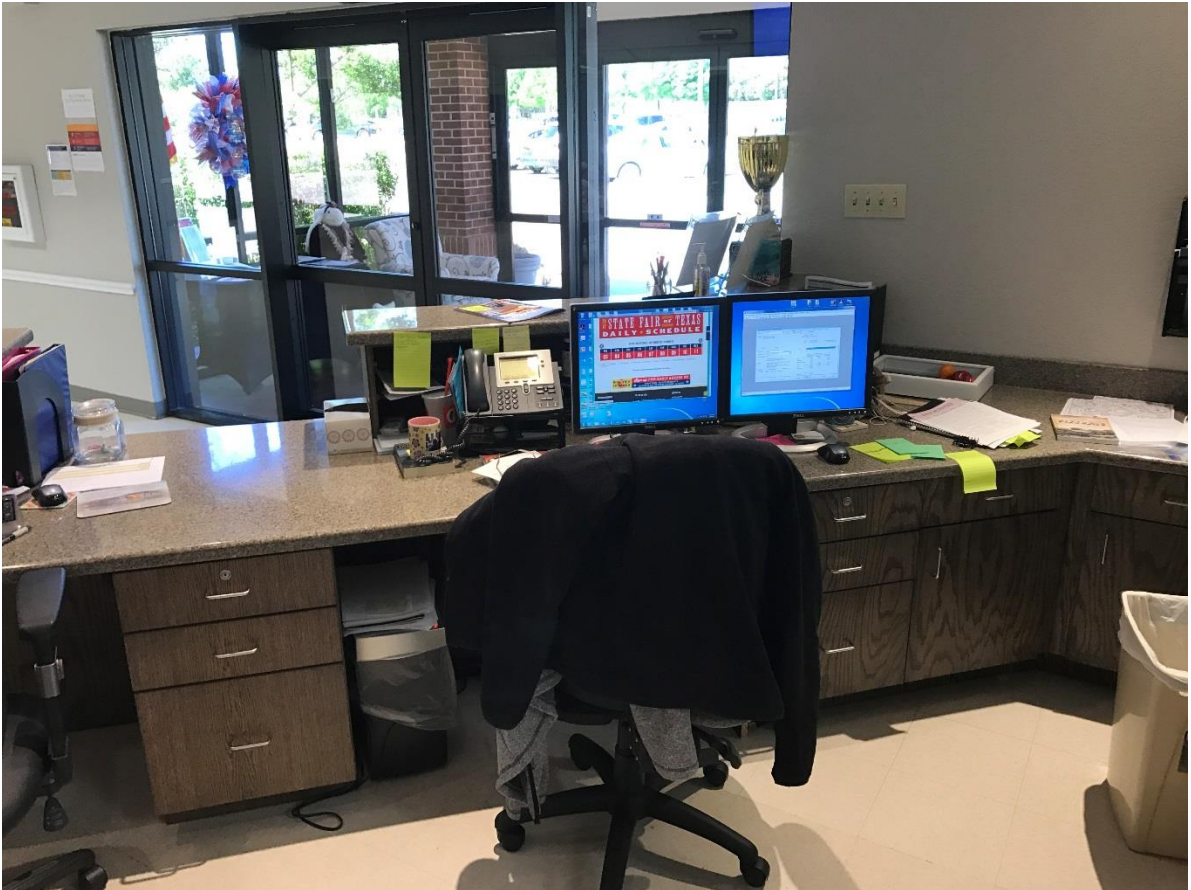
Control desk
